GUAM ENVIRONMENTAL PROTECTION AGENCY • *AHENSIAŇ PRUTEKSIÓN LINA'LA' GUÅHAN*

July 23, 2021

SUBJECT: Site Inspections at Samsung Mangilao Solar Project Site, July 23 and 18, 2021

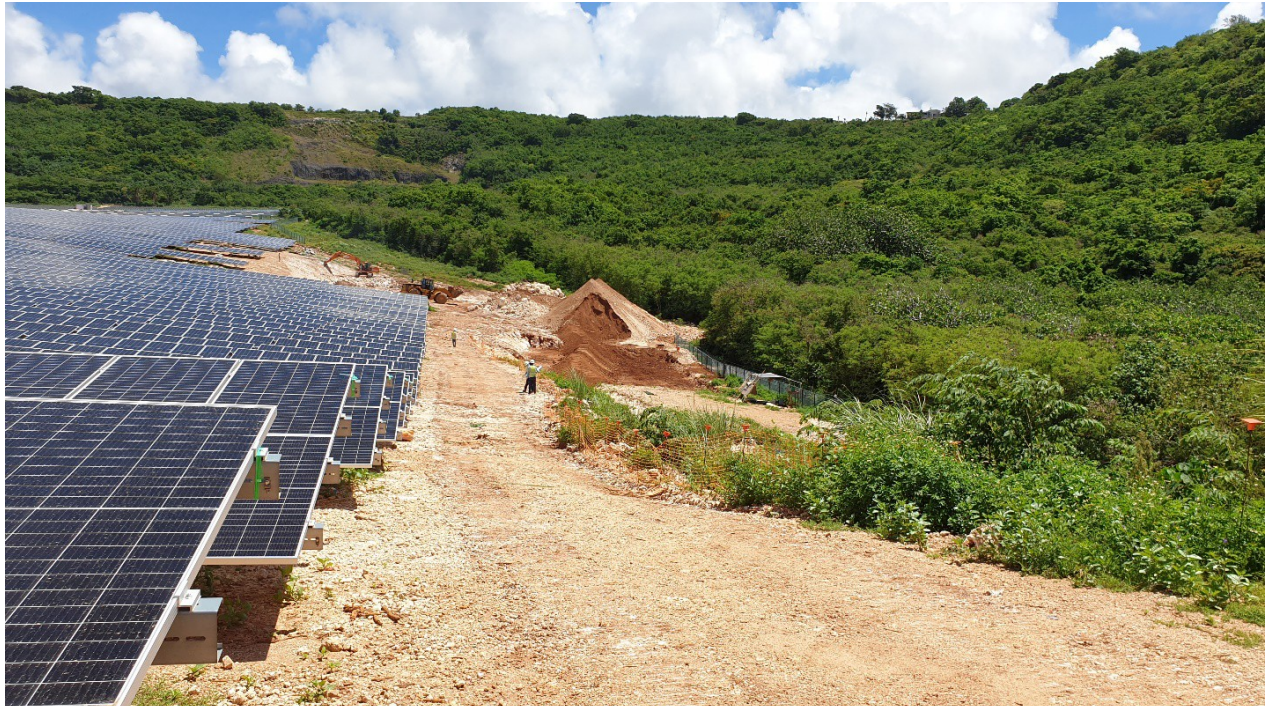
The location of the Marbo Cave discharge and Pond 5, showing activity underway to install E&SC measures on July 28, 2021:

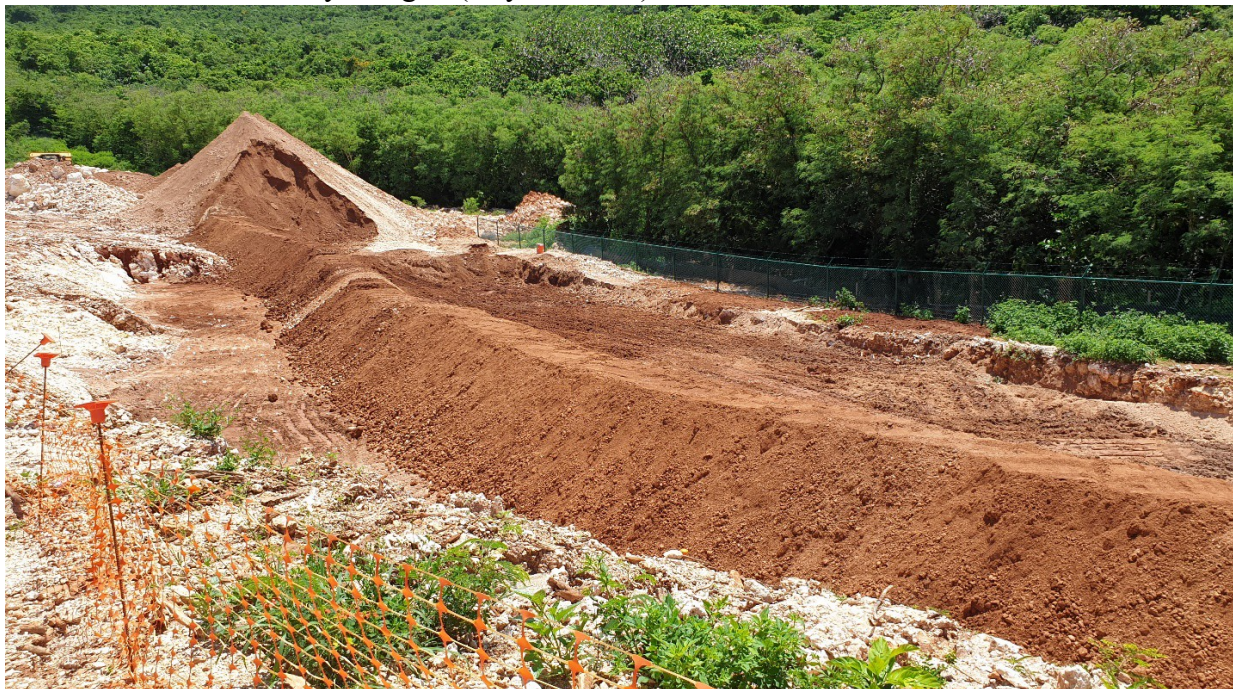
Pond 5B installation had only just begun, following our July 23 inspection. Mr. Kim explained that a temporary pond had been created using the available earth fill material, as shown in the photos. The permanent pond will be formed by the embankment downhill from the temporary embankment, but placement and compaction of fill for the permanent embankment had not yet begun. I expressed my concern to Mr. Kim that the temporary pond berm might be easily washed out by another large storm event because it appeared to have not been compacted in lifts, and was constructed of a topsoil-like material that did not appear to meet the typical requirements for embankment fill.

The beginning of construction work for Pond 5B. The soil embankment is to delineate a temporary storage pond, while the permanent embankment is installed just beyond (to the right). Base preparation for the permanent embankment has begun, but emplacement and compaction of embankment fill had not yet begun (July 28, 2021):

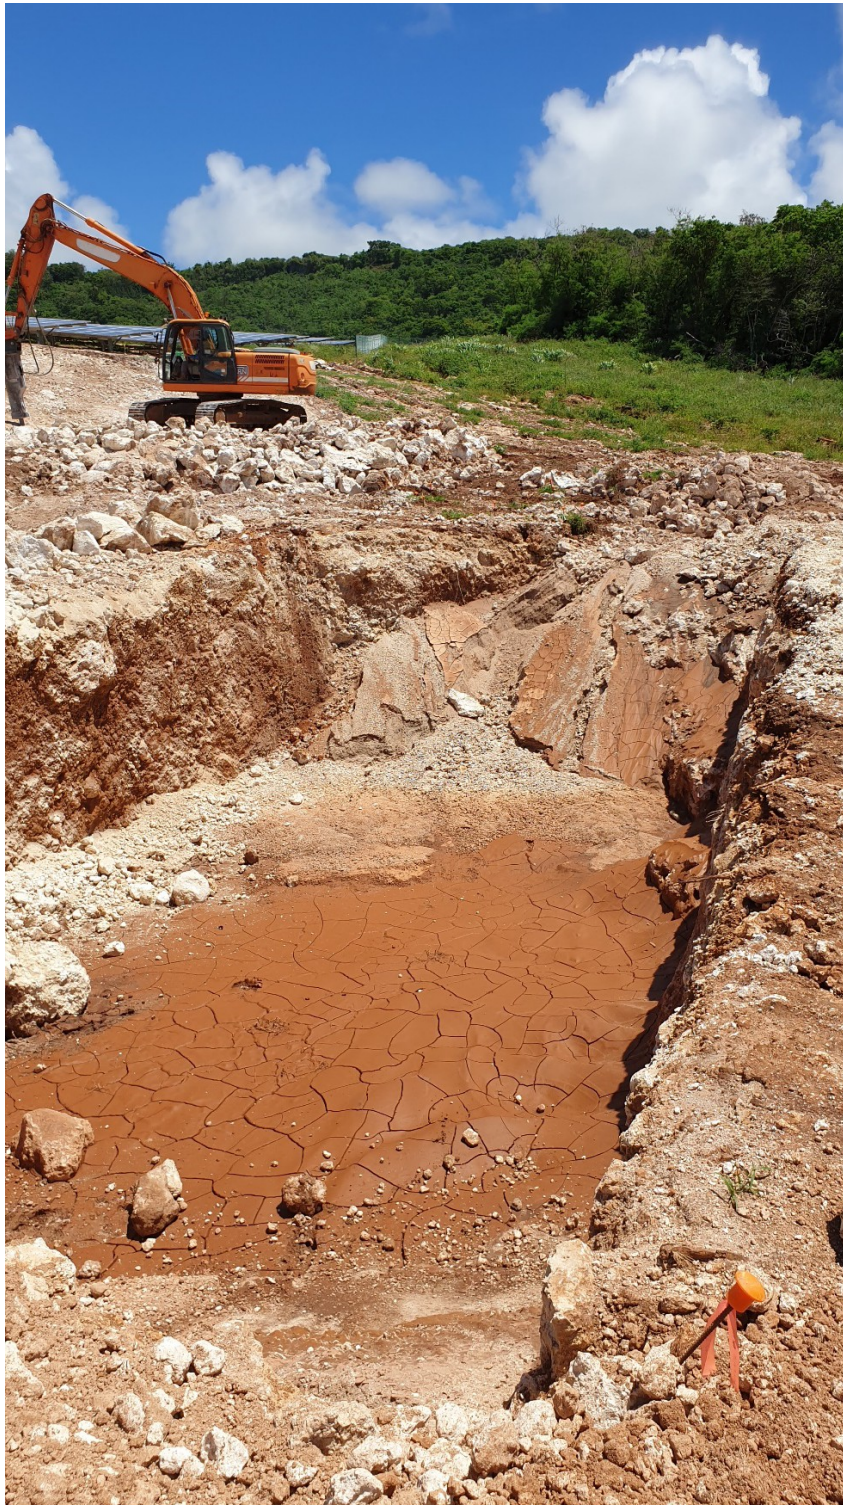
Pond 5A excavation, which according to Samsung site personnel was begun in June. However the excavation is not yet connected to the site swale, so mass runoff is unable to enter the basin. Sedimentation pictured is from incidental runoff that the excavation collected due to its location (July 28, 2021):

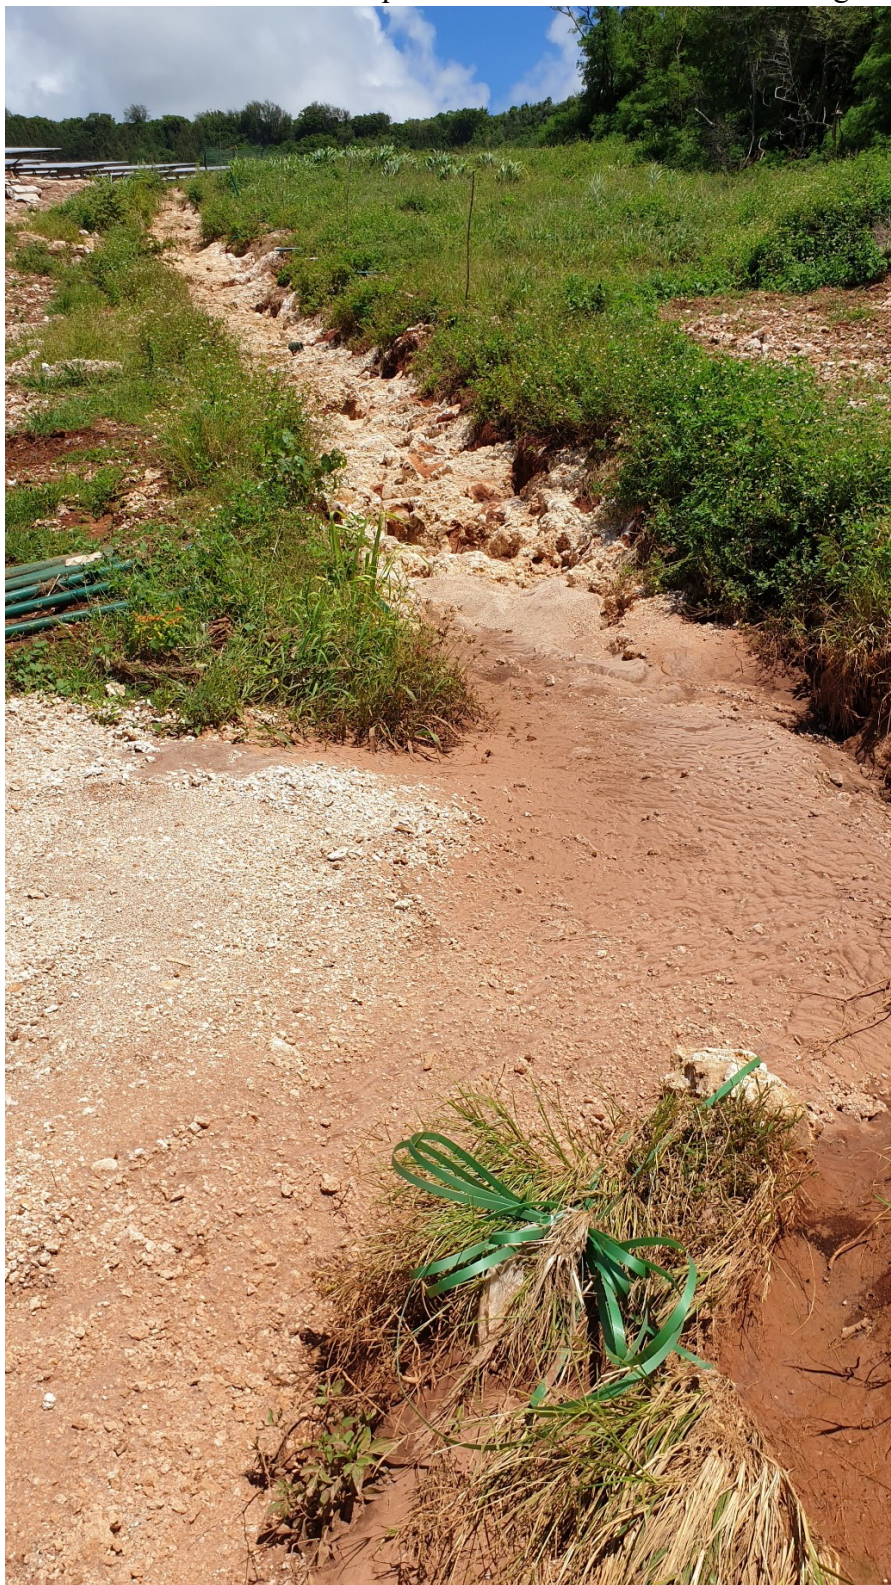
The perimeter swale which would discharge to Pond 5, but at the time of inspection it was not connected and sedimentation patterns showed that runoff discharged off-site (July 28, 2021)

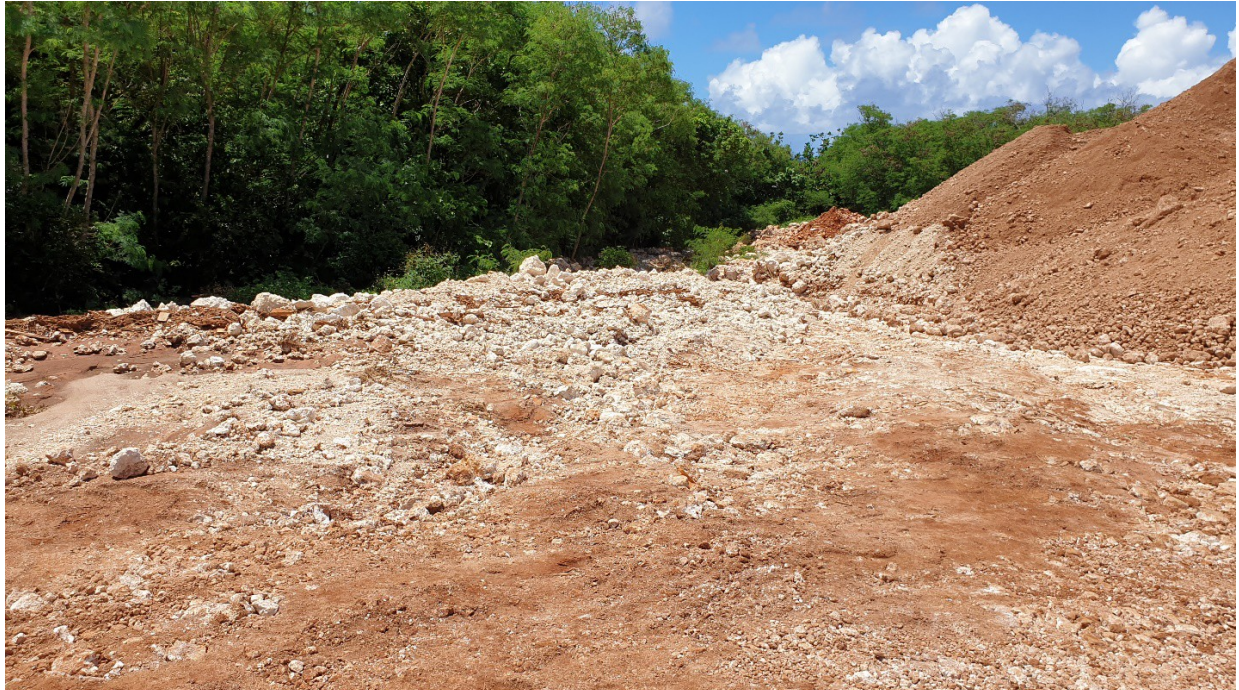
We observed that the perimeter swale had discharged to the open ground near the fence, and along with the surface runoff from the surround project area, had left a very large alluvial/delta formation of sediments, up to and including rocks around 1 to 2 feet in diameter. The deposited sediments could be seen extending into the forest far past the site boundaries, toward the Marbo Cave area.

This is the area where the perimeter swale currently discharges. A large delta-type (alluvial) formation of sediment is evident, showing that a large volume of runoff discharged off-site during the recent rainfall events (July 28, 2021).

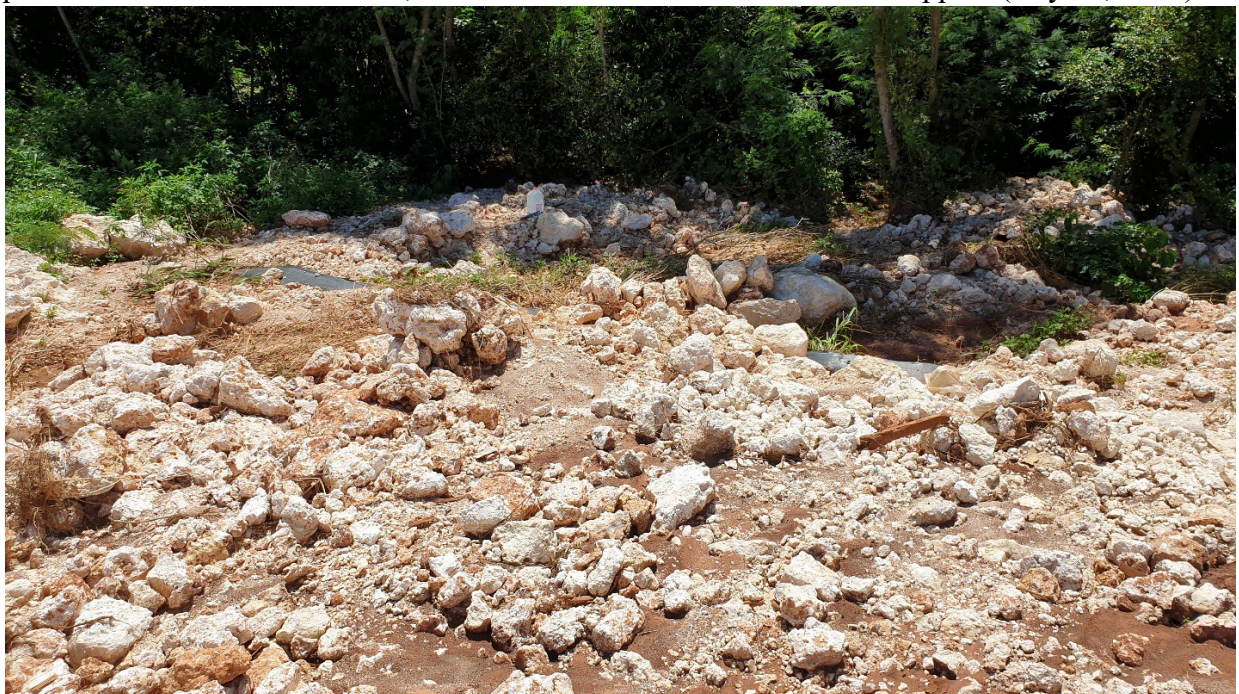
A view of the sediment discharged off-site during the recent rainfall events. The size of the deposited rocks demonstrates that flow volumes and velocities were very high. The top of the perimeter silt fence can be seen, where it was knocked down and overtopped. (July 28, 2021)

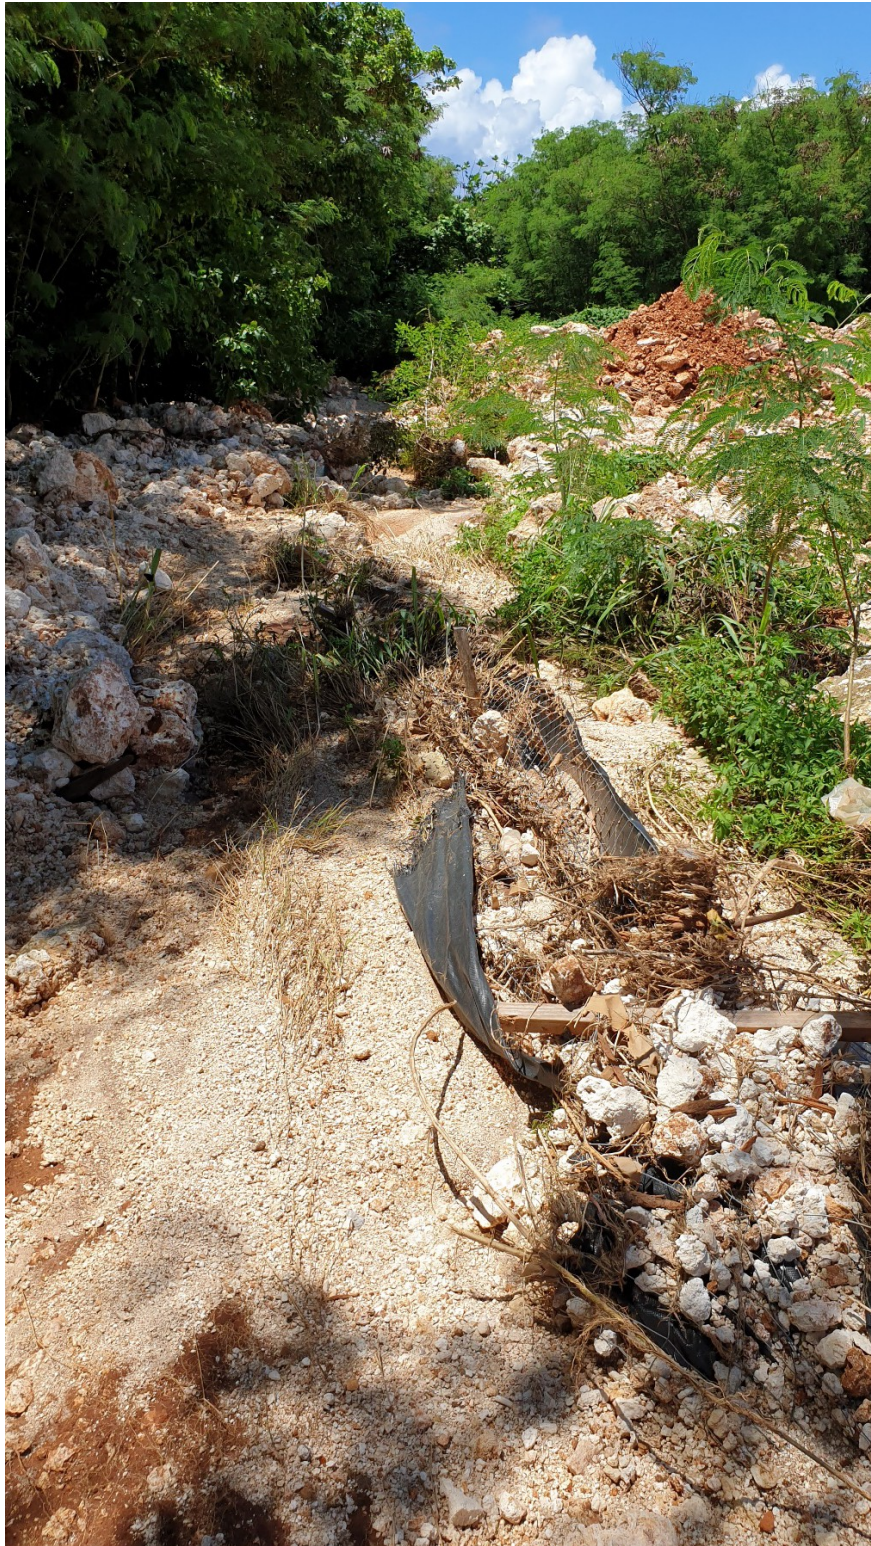
Another view of the sediment plume/delta formation resulting from the off-site discharge during the rain events the week of July 19. This photo is looking toward the off-site properties, headed downhill roughly in the direction of Marbo Cave. (July 28, 2021)

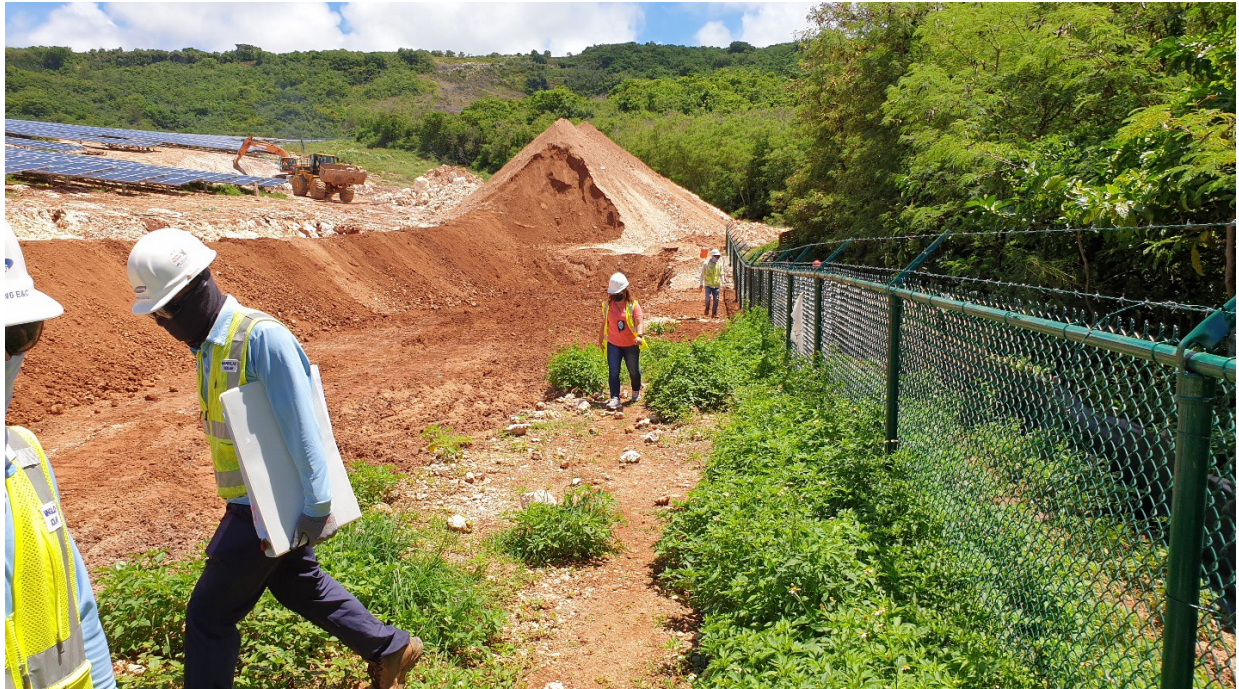
View toward Pond 5B location. The graded area to the right of the earthen embankment is the base of the permanent pond embankment, which Samsung had not yet begun to install. (July 28, 2021)

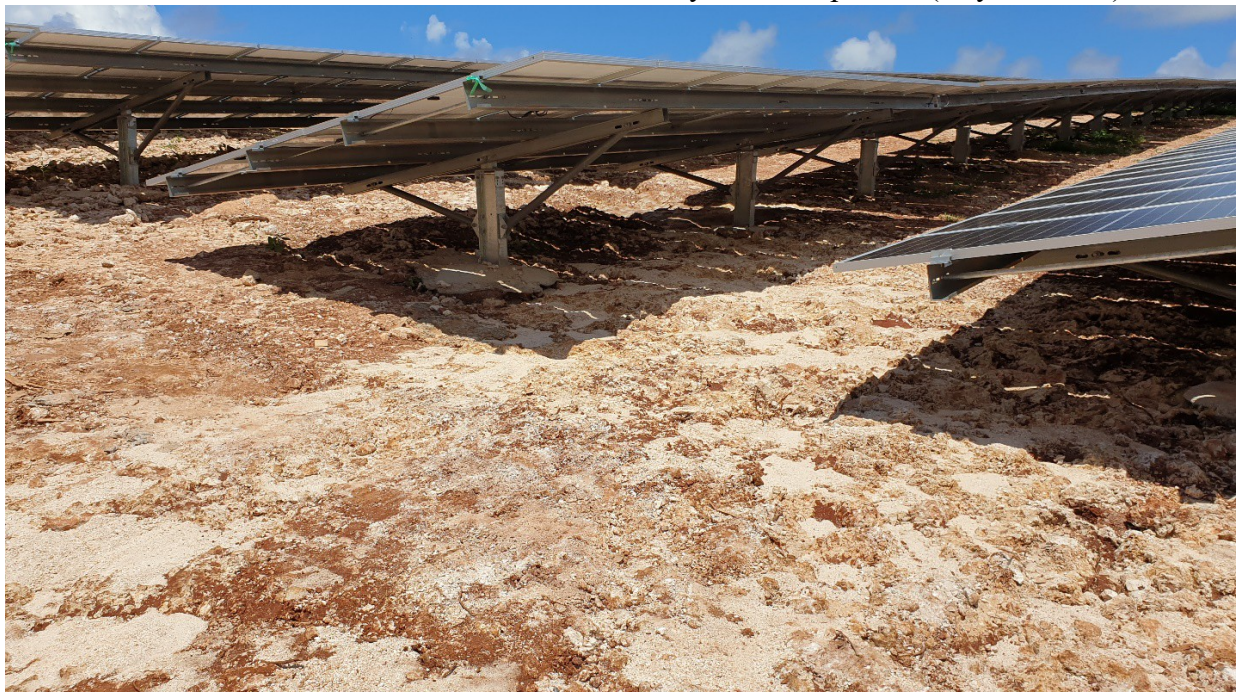
We observed extensive scouring and erosion of almost the entire upland project area above the Pond 5 area, with the ground surface beneath the solar panels visibly scoured down to bare limestone, with only thin deposits of sand and other sediments showing the direction that runoff had taken during the heavy rains the week before.

A partial view of the uphill project area which contributed to the discharge of runoff the week of July 19. Soil and fill material has been scoured from an area several hundred feet wide, leaving bare limestone bedrock in much of the area covered by the solar panels. (July 28, 2019)

- I recommended that Samsung take active steps to begin re-vegetating the site to stabilize the soils, which will reduce both runoff volume and the quantity of sediment that accumulates in the ponds.
